TECHNICAL REPORT CERC-87-10

# HURRICANE ELENA STORM SURGE DATA

## Report 3

## HURRICANE ELENA STORM SURGE DATA

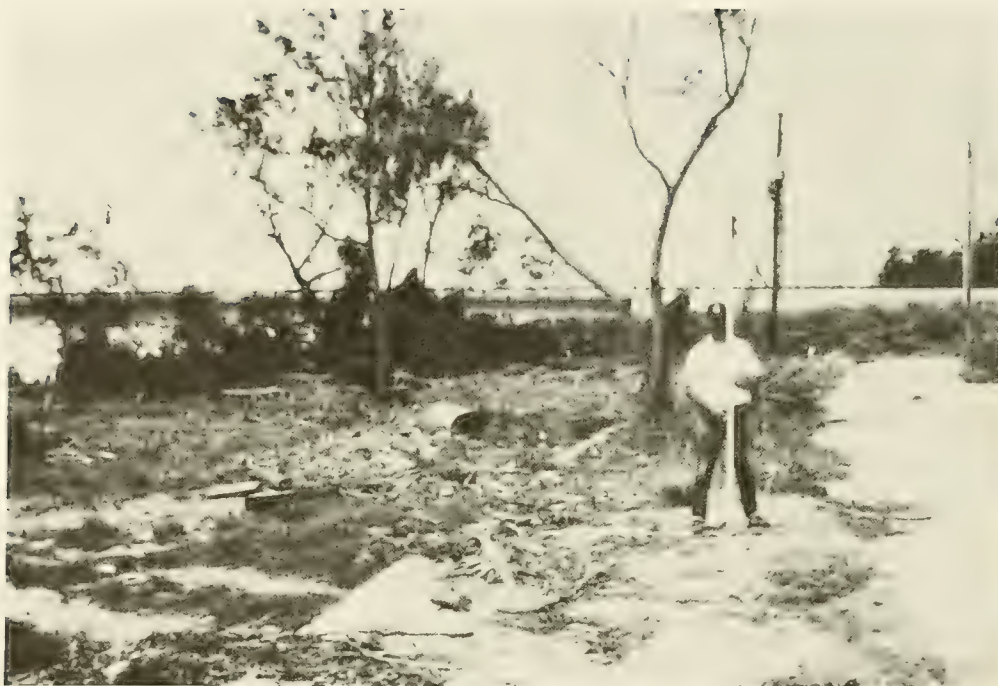
14. Trash lines remained all around the shores of Biloxi Bay. On the eastern side of the bay at the location of the Biloxi fishing bridge (the remnant of the old Highway 90 bridge), the surge washed across part of a shore-front road. Photo 1 shows this trash line being surveyed. The elevation of the surge induced flooding did not exceed +3 ft NGVD at this point.

Photo 1. Surveying debris line at the east end of old Highway 90 fishing bridge, Biloxi, Miss.

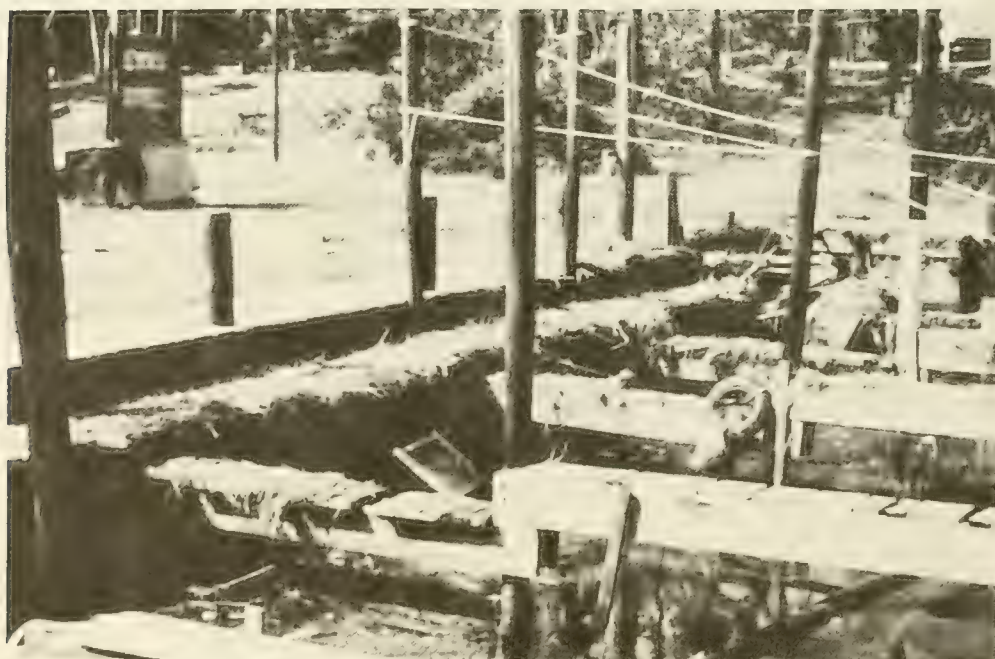
15. Between Biloxi Bay and Pascagoula Bay, 15 miles to the east, the elevation of the high-water mark was about +6 ft NGVD. At the location of the Mississippi Gulf Coast Research Lab on Davis Bayou (southeast of Ocean Springs, Miss.), the high water overtopped the docks and bulkheads around a small-boat harbor (Photo 2). A large amount of debris was left at the +5-ft NGVD line, but there was minimal flooding at the laboratory facilities.

Photo 2. Debris line on docks at the Mississippi Gulf Coast Research Lab on Davis Bayou

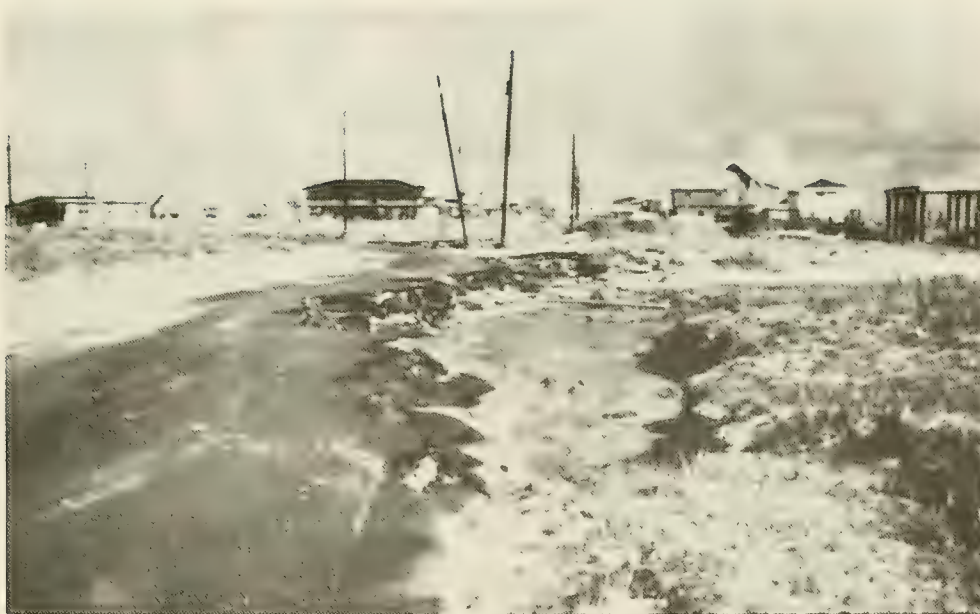
16. The hardest hit area on the coast was Dauphin Island, Ala., which was directly in the path of the hurricane's track just prior to landfall. There was extensive wind damage all over the island, but the majority of the damage caused by the surge was seen on the western half of the island where the surge passed completely over the island at a number of locations. This resulted in gullying which damaged roads (Photo 3) and undermined the foundations of houses (Photo 4). The high-water mark at these locations measured +6.5 ft NGVD. The small-boat harbor on the northeast side of the island suffered very little structural damage, but some of the boats were damaged or sunk when they broke free of their moorings (Photo 5). The only major surge-induced damage on the eastern end of the island occurred at Pelican Point where the deck of the wooden pier supporting the NOS/CE surge gage was destroyed (Photo 6). The high-water level at this location was about +6.7 ft NGVD with wave runup heights exceeding +8.0 ft NGVD.

Photo 3. Damage to road on north side of Dauphin Island,  
looking west

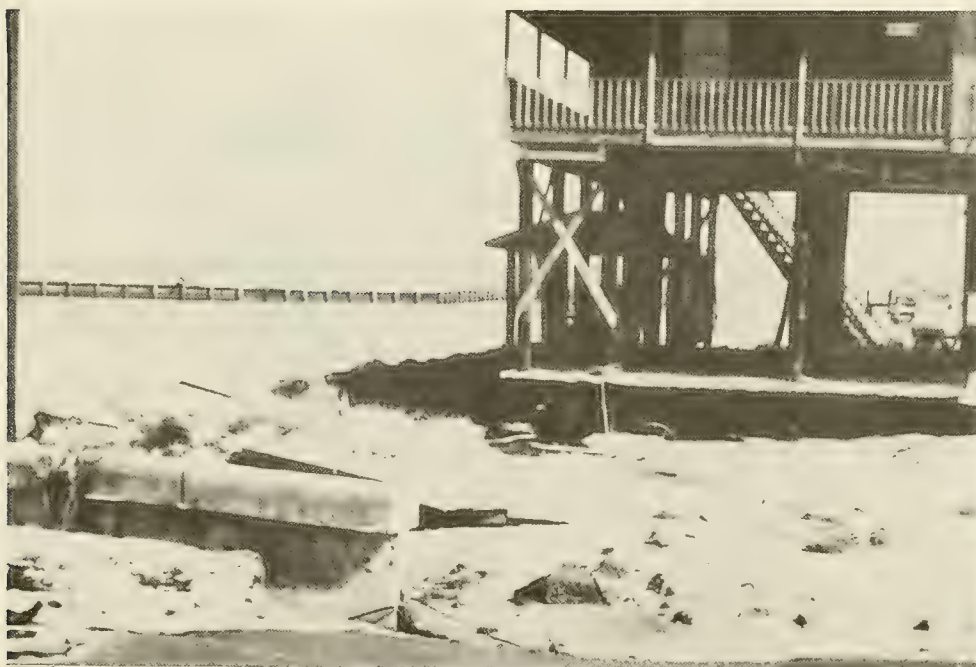
Photo 4. Foundation damage on the western half of  
Dauphin Island, bay side

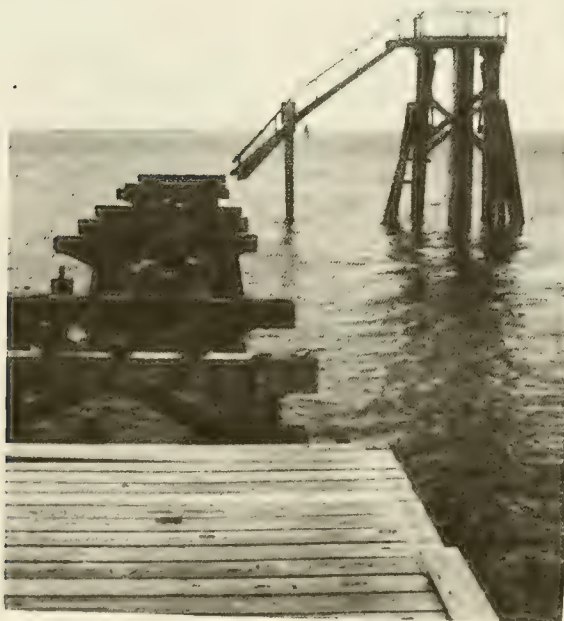
Photo 6. Pier damage at Pelican Point on the eastern end of Dauphin Island showing the NOS tide station where hydrograph of Dauphin Island (2) was obtained

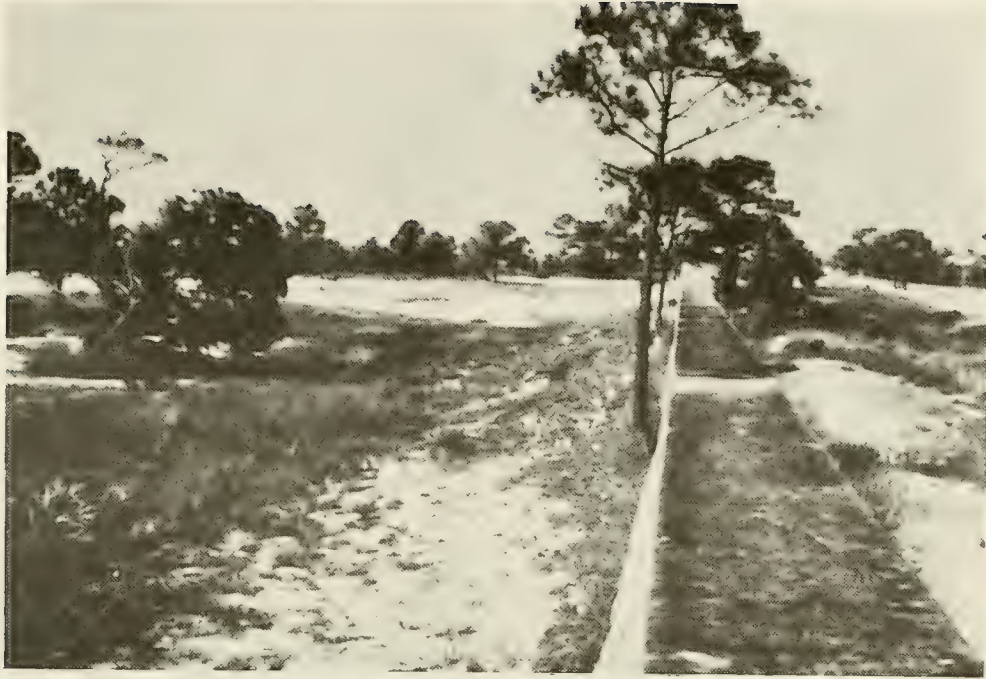
entrance to Mobile Bay exceeded +8 ft NGVD and reached the base of the seawall in Fort Morgan State Park (Photo 7). Within the boundaries of the state park, there were several locations where the surge passed completely over the spit, resulting in highway erosion (Photo 8). While surge related damage was confined to the highway, high winds totally destroyed one building and severely damaged several others in the park. Surge elevations dropped rapidly east of the park to an average of +4 ft NGVD. This was sufficient to cause some flooding in the communities located between the park and the city of Gulf Shores. However, the amount of structural damage was minimal as can be seen by the house shown in Photo 9.

Photo 7. Debris line at the foot of the seawall,  
Ft. Morgan State Park, Ala., looking west

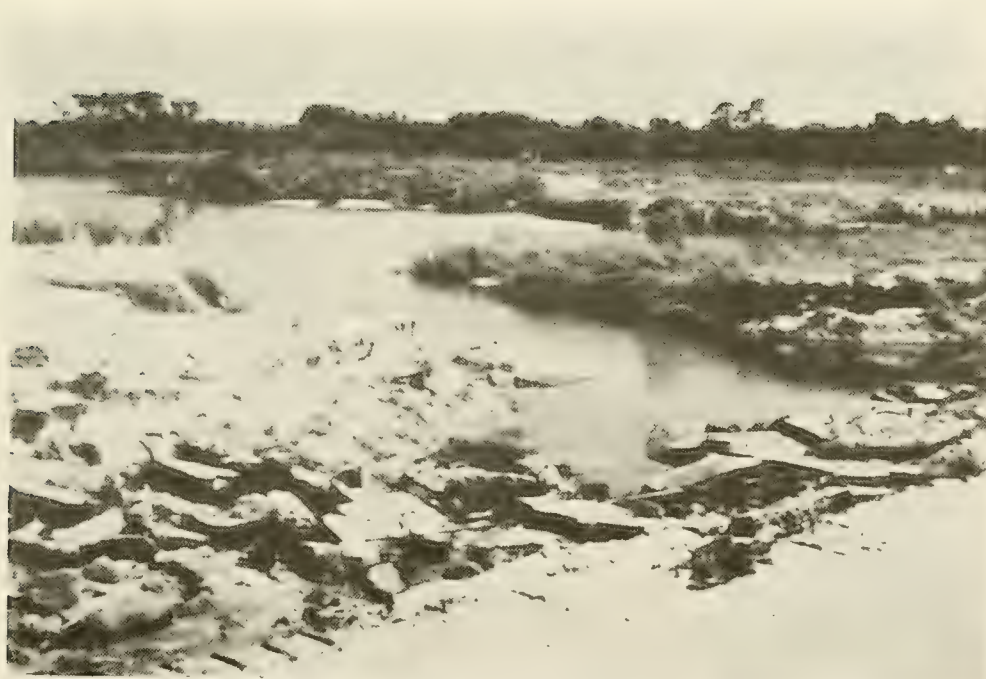
Photo 8. Evidence of overwash resulting in road damage in  
Ft. Morgan State Park, looking north

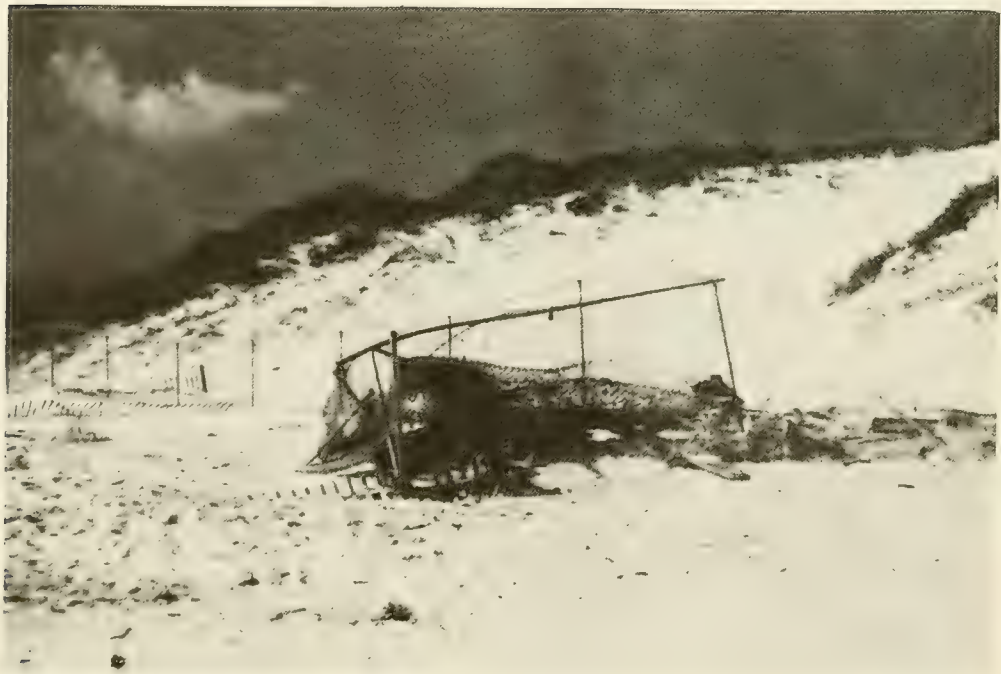
18. Throughout the western part of the Florida panhandle the measured high-water marks were less than +5 ft NGVD. Thus, actual damage resulting from surge was limited to minor highway damage and to structures located very close to the high-water mark such as the chain link fence in Pensacola Beach shown in Photo 10. In Destin, the surge and wave runup cut through a dune line (Photo 11) and flooded a lagoon located behind the dune line. The water level in the lagoon rose approximately 5 ft but did not flood any of the structures surrounding it. Farther east along the coast, surge levels continued to diminish with most high-water marks at an elevation of less than +4 ft NGVD. However, some damage did occur at several locations. One such location was the Dan Russell City Pier in Panama City Beach, Fla. The concrete decking on the end of the pier was lifted and broken by waves (Photo 12). This damage occurred at an elevation of approximately +20 ft NGVD, at a location where the measured wave runup did not exceed +10 ft NGVD, and is probably the result of the seaward end of the pier being in the breaker zone during part of the storm.

Photo 10. Damage to chain link fence in front of dune line at Pensacola Beach, Fla.

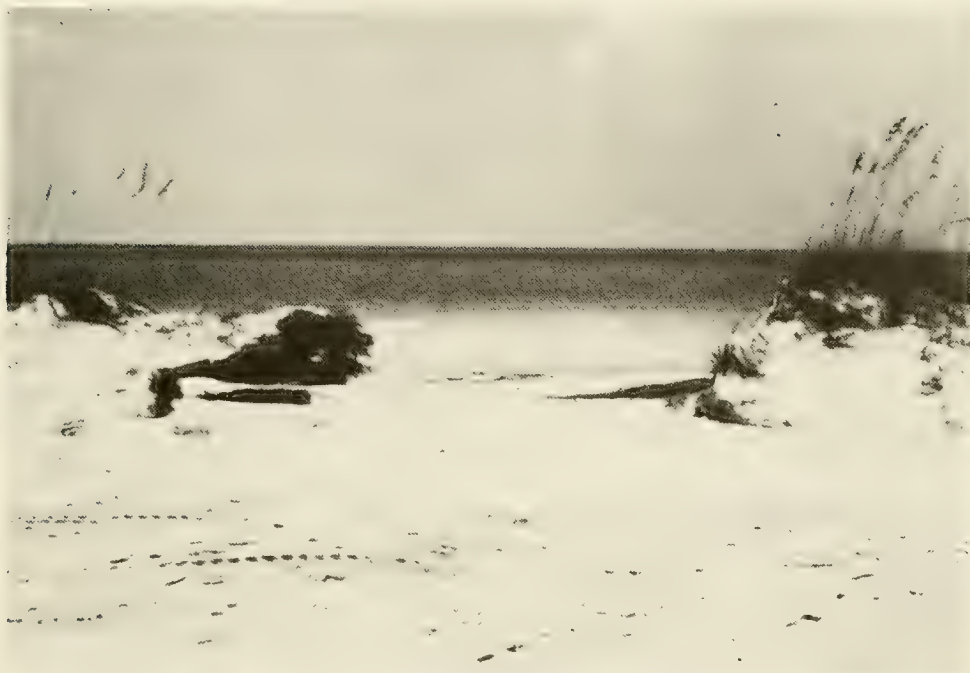
Photo 11. Cut through dune line in Destin, Fla.,  
looking south

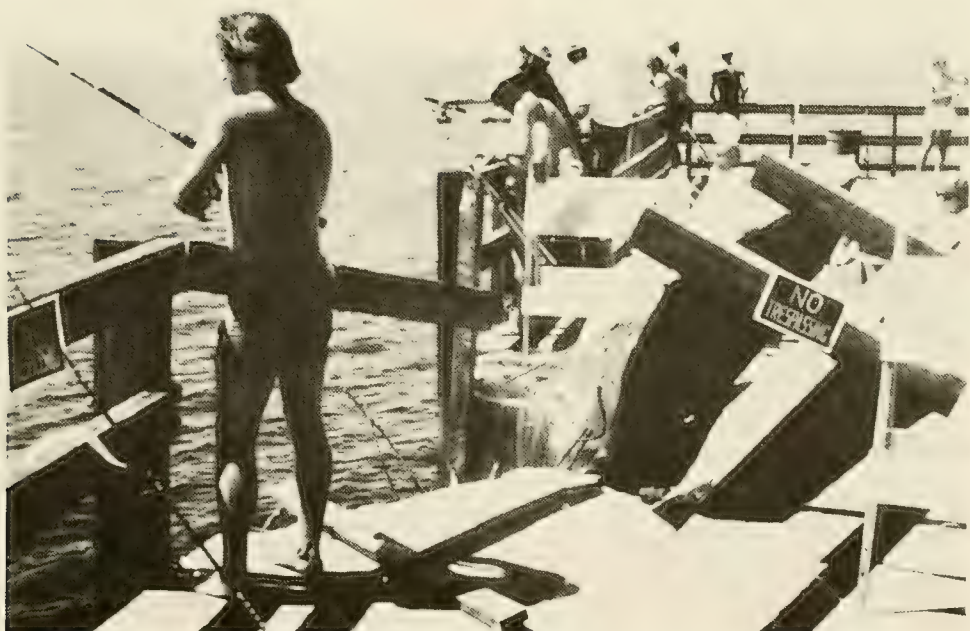
Photo 12. Damage to the decking of Dan Russell City Pier at  
Panama City Beach, Fla.
